Gasoline Tanker Incidents in Chicago, Illinois and Fairfax County, Virginia

Gasoline Tanker Incidents in Chicago, Illinois and Fairfax County, Virginia (March 30, 1989 and May 29, 1989)

Case Studies in Hazardous Materials Planning

**This is Report 032 of the Major Fires Investigation Project conducted
by TriData Corporation under contract EMW-88-C-2849 to the United
States Fire Administration, Federal Emergency Management Agency.**

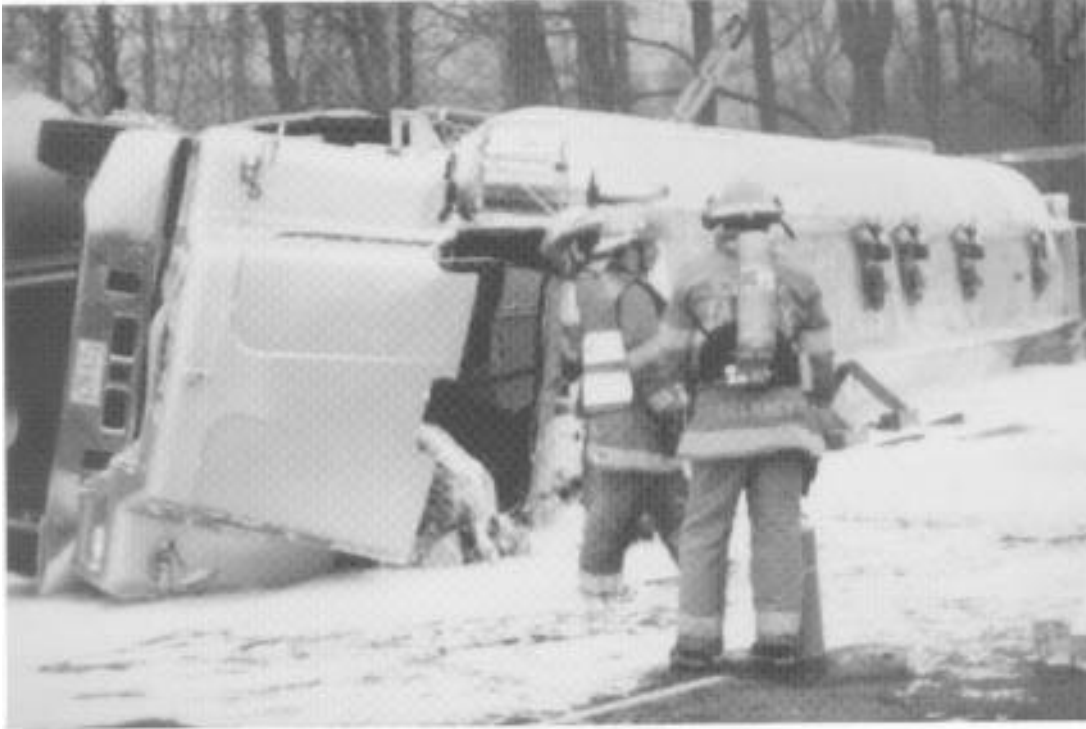
Because of the position of the tanker and the fact that the dome covers were damaged, it was decided that the best way to remove the product would be by cutting a hole in the side of the tank (see Fairfax County Hazardous Material Response Team Manual, Appendix D).

1. Overturned tanker showing dome covers

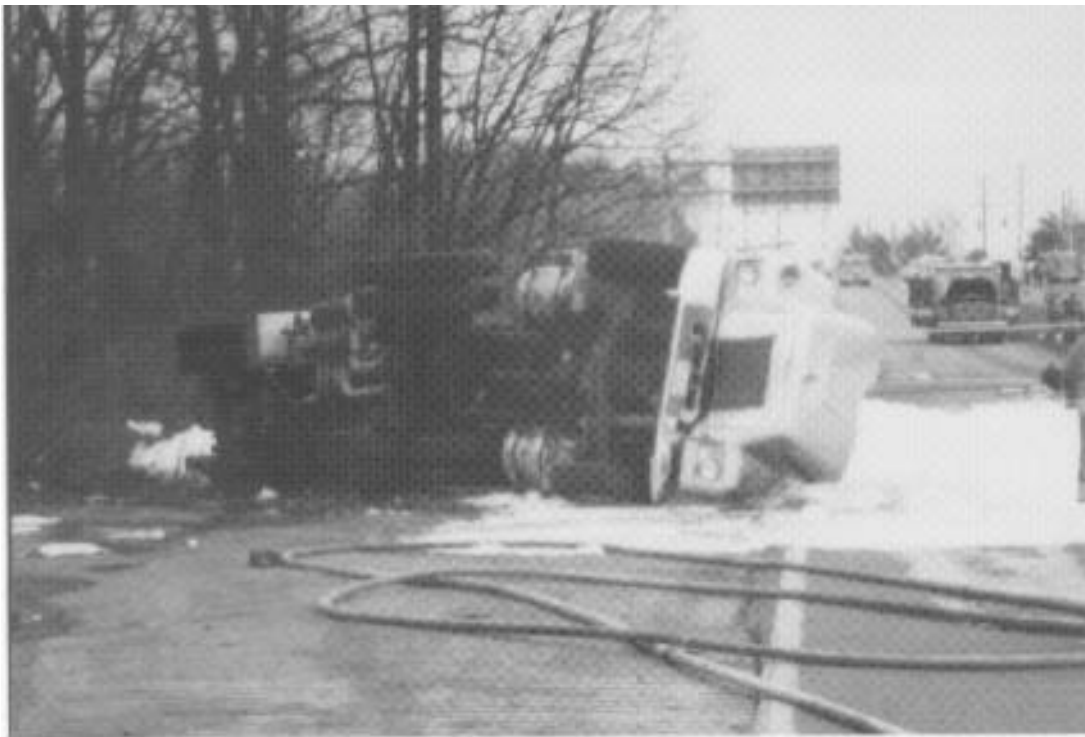
2. Tanker, sprawled on roadway; hazmat unit is in background.
3. (next page) Aerial view of accident scene. I-495 across center of photograph, Route 7 runs vertically in center of photograph.

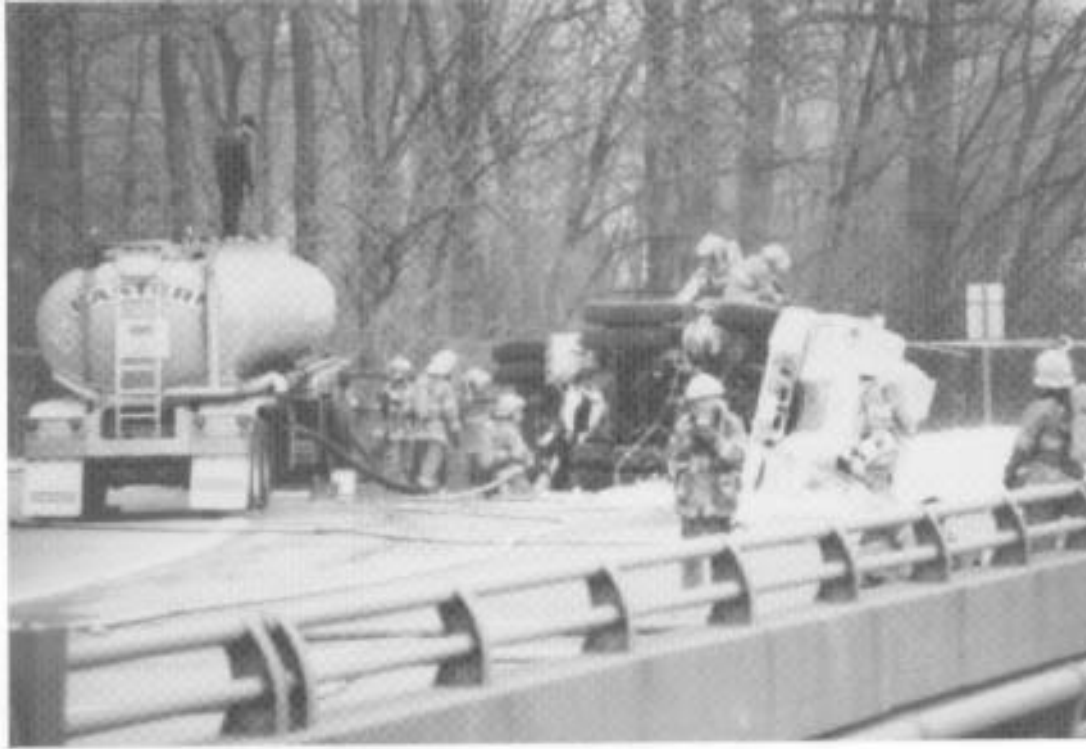
4. Second tanker pumping fuel from the overturned tanker.

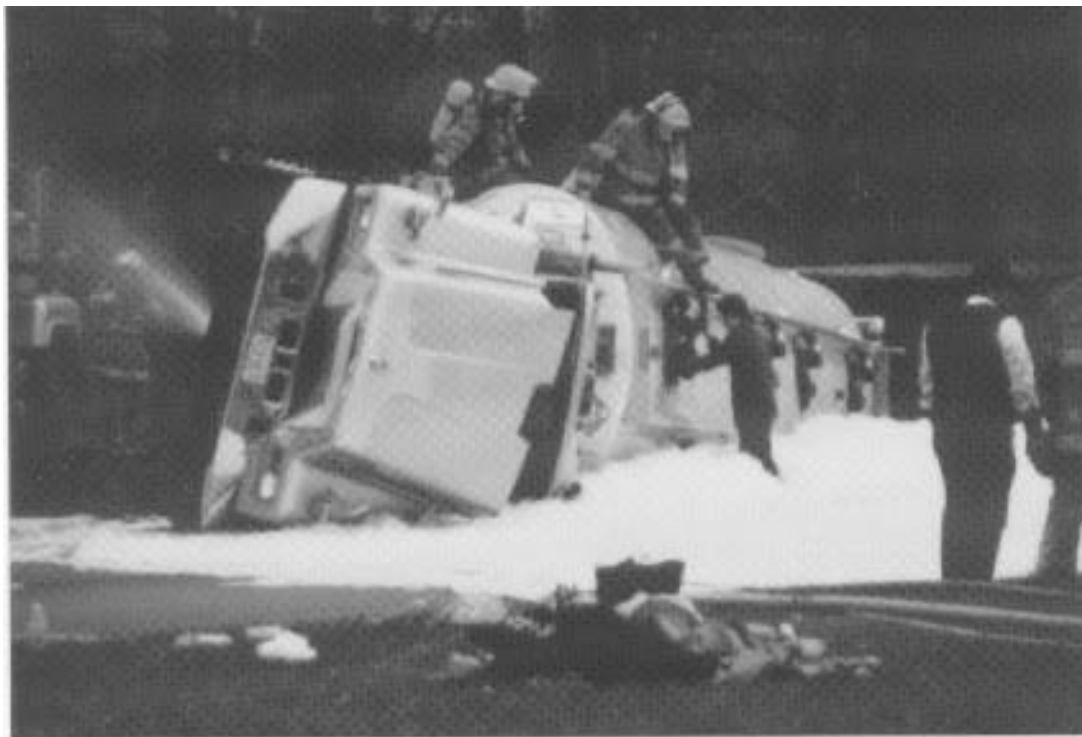
5. Contractor personnel complete off-loading operation. Firefighters atop tank are at position of hole that was drilled. Note water spray directed at exhaust pipe of the recovery tanker.

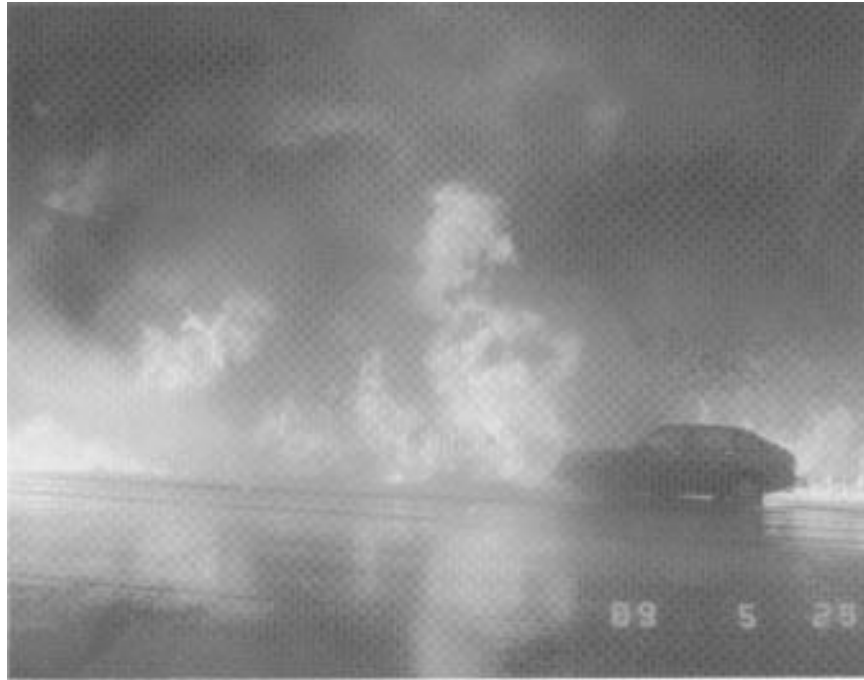
1. Fire conditions along Fullerton street between tanker and "el" tracks.

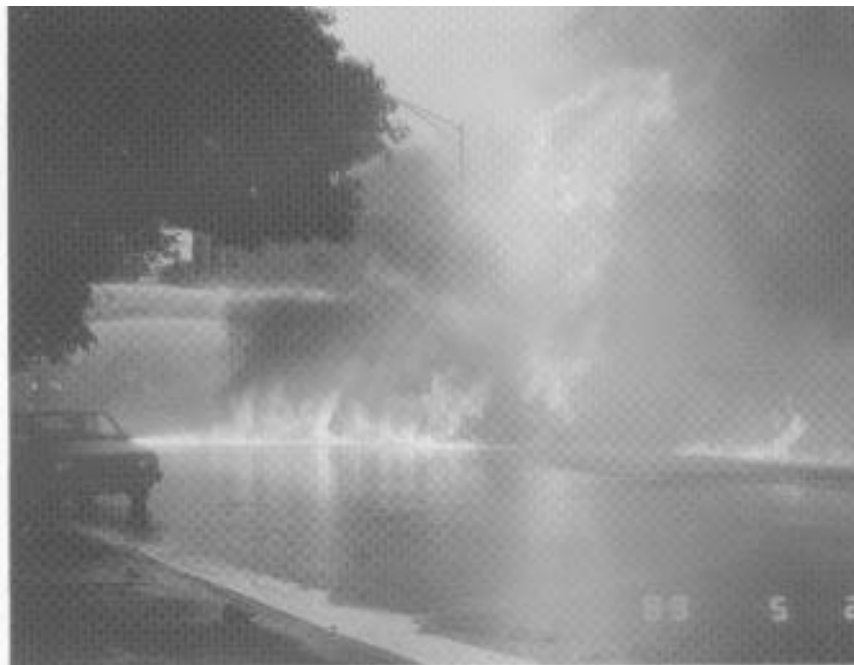
2. First streams (arrow) in operation on tanker; 2 story exposure building is obscured by fire and smoke.

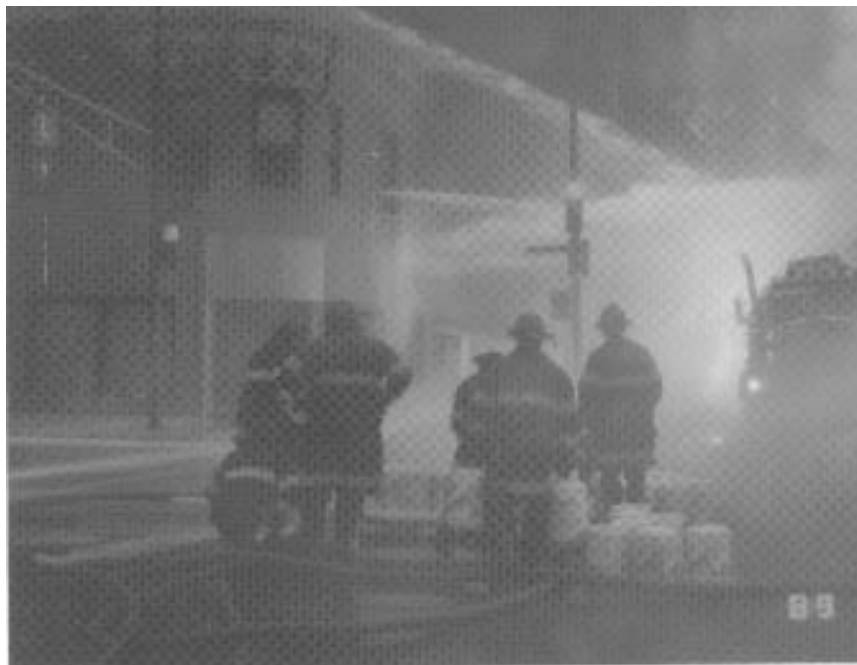
4. Firefighters operate foam handline to control spill fire. Note streams directed at exposure and tanker, including from second floor of exposure.

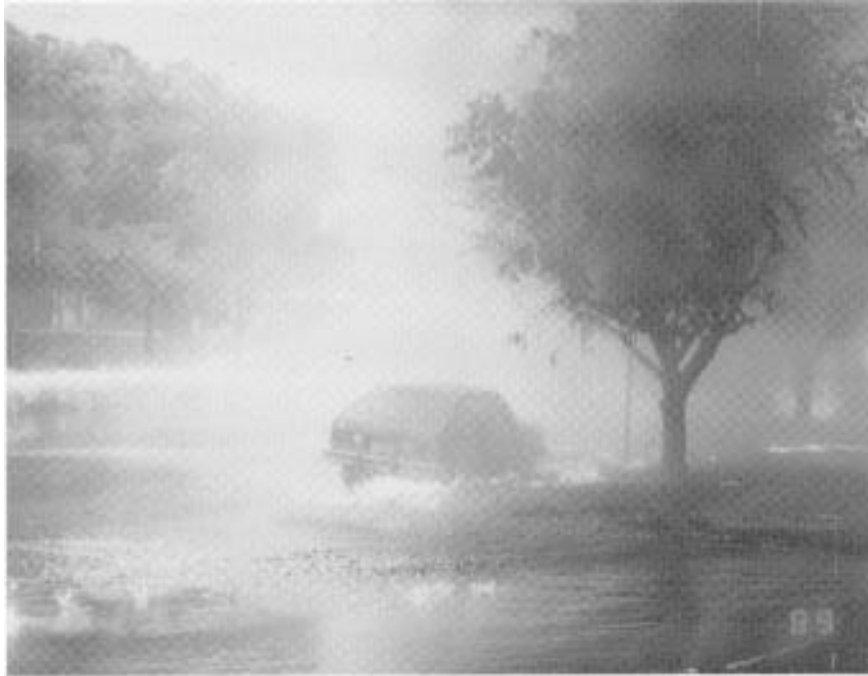
7. Spill fire flares up as it flows around parked car. Note runoff in foreground.

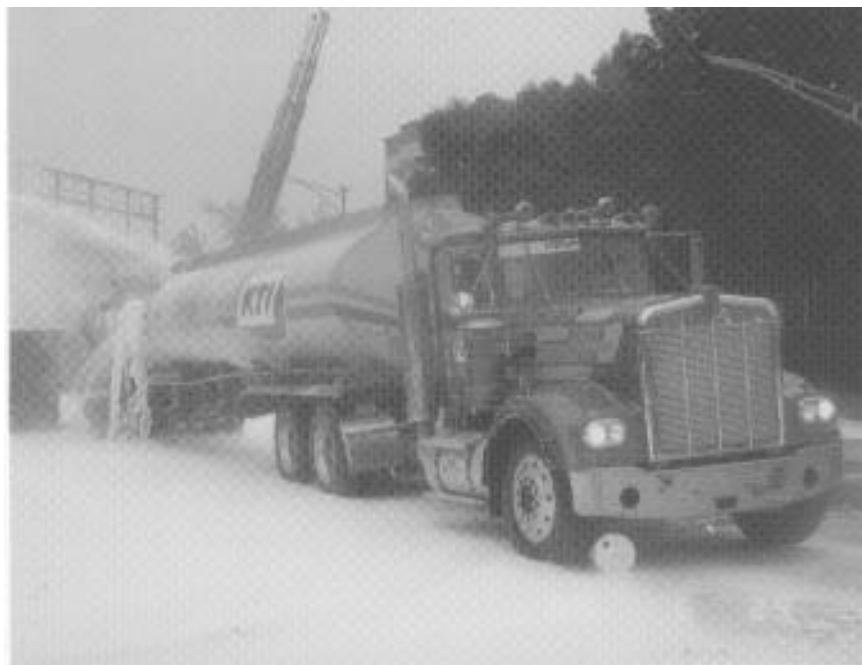
10. Fire out, but product continues pouring from tank trailer.

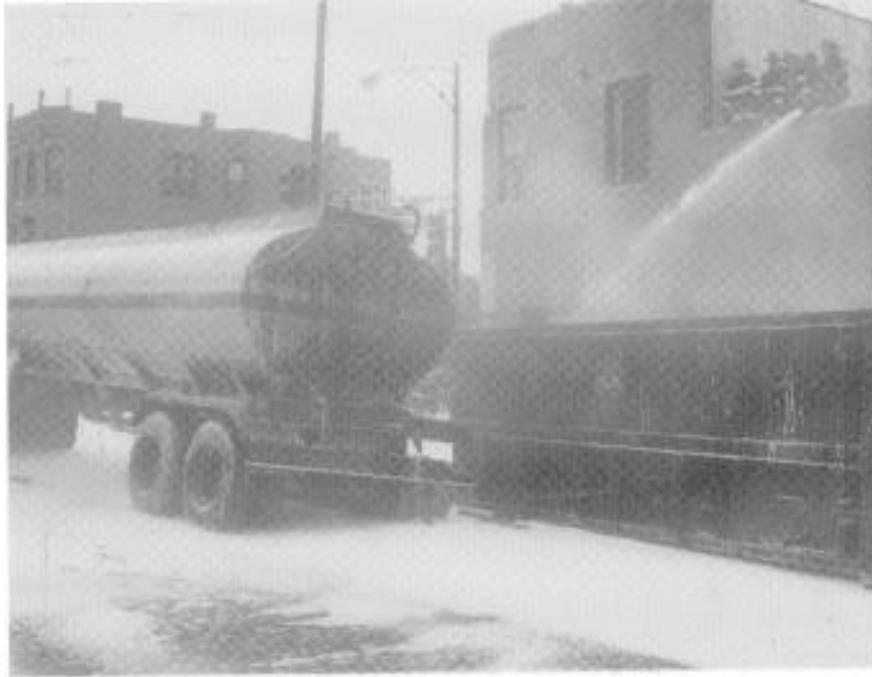
11. Firefighters flood debris in dumpster to prevent reignition of gasoline.

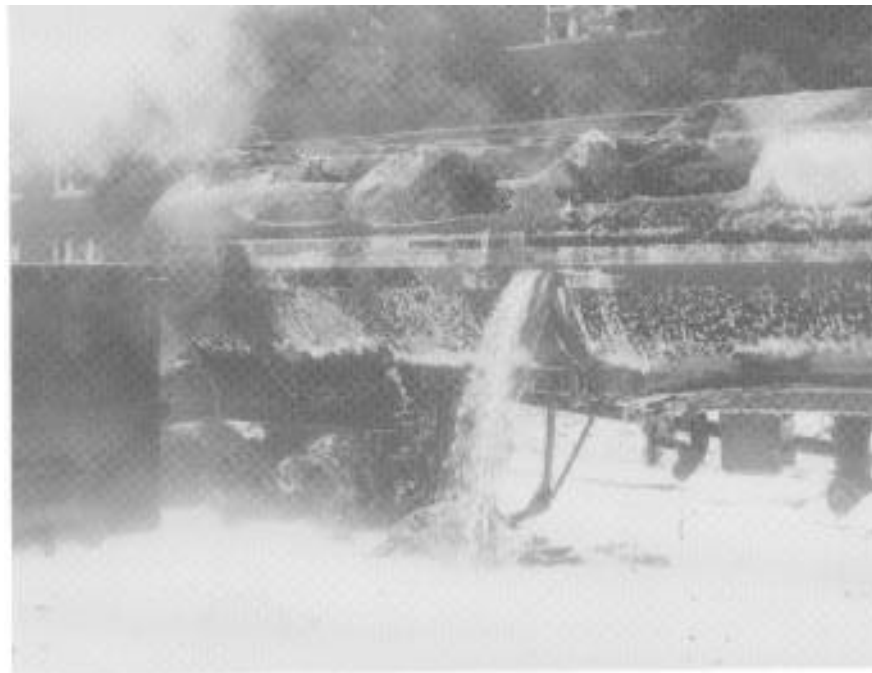
12. Damage to rear of tank trailer; gasoline still pours from puncture.

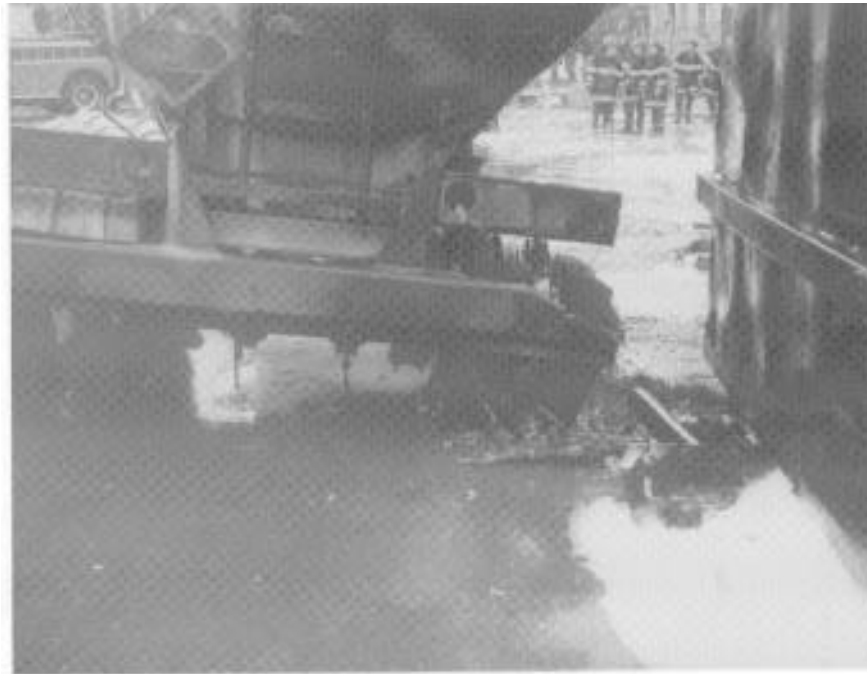
13. Rear of tanker, left side tires are intact.

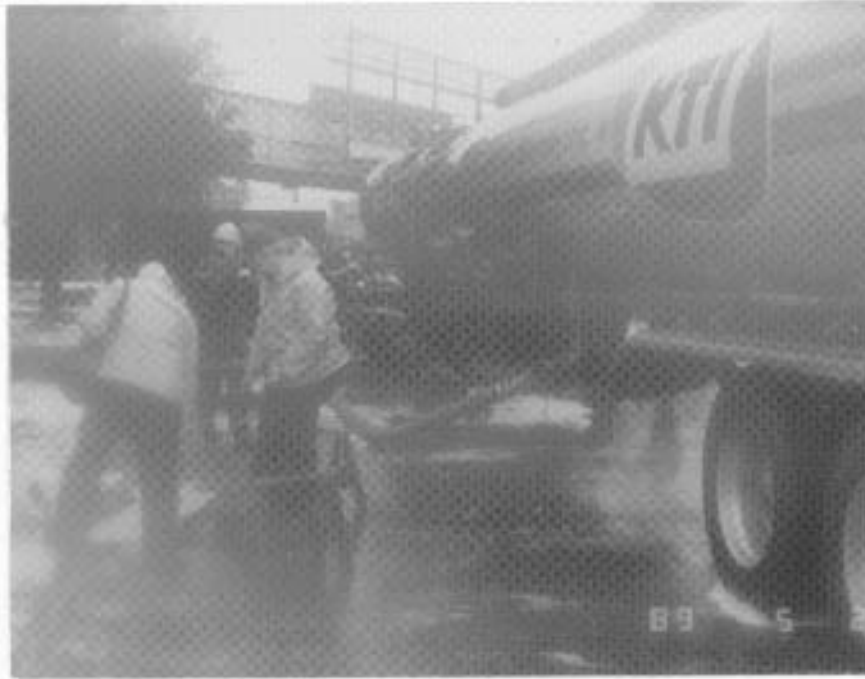
15. Off-loading in progress, Water Department employees check manhole for explosive vapors.

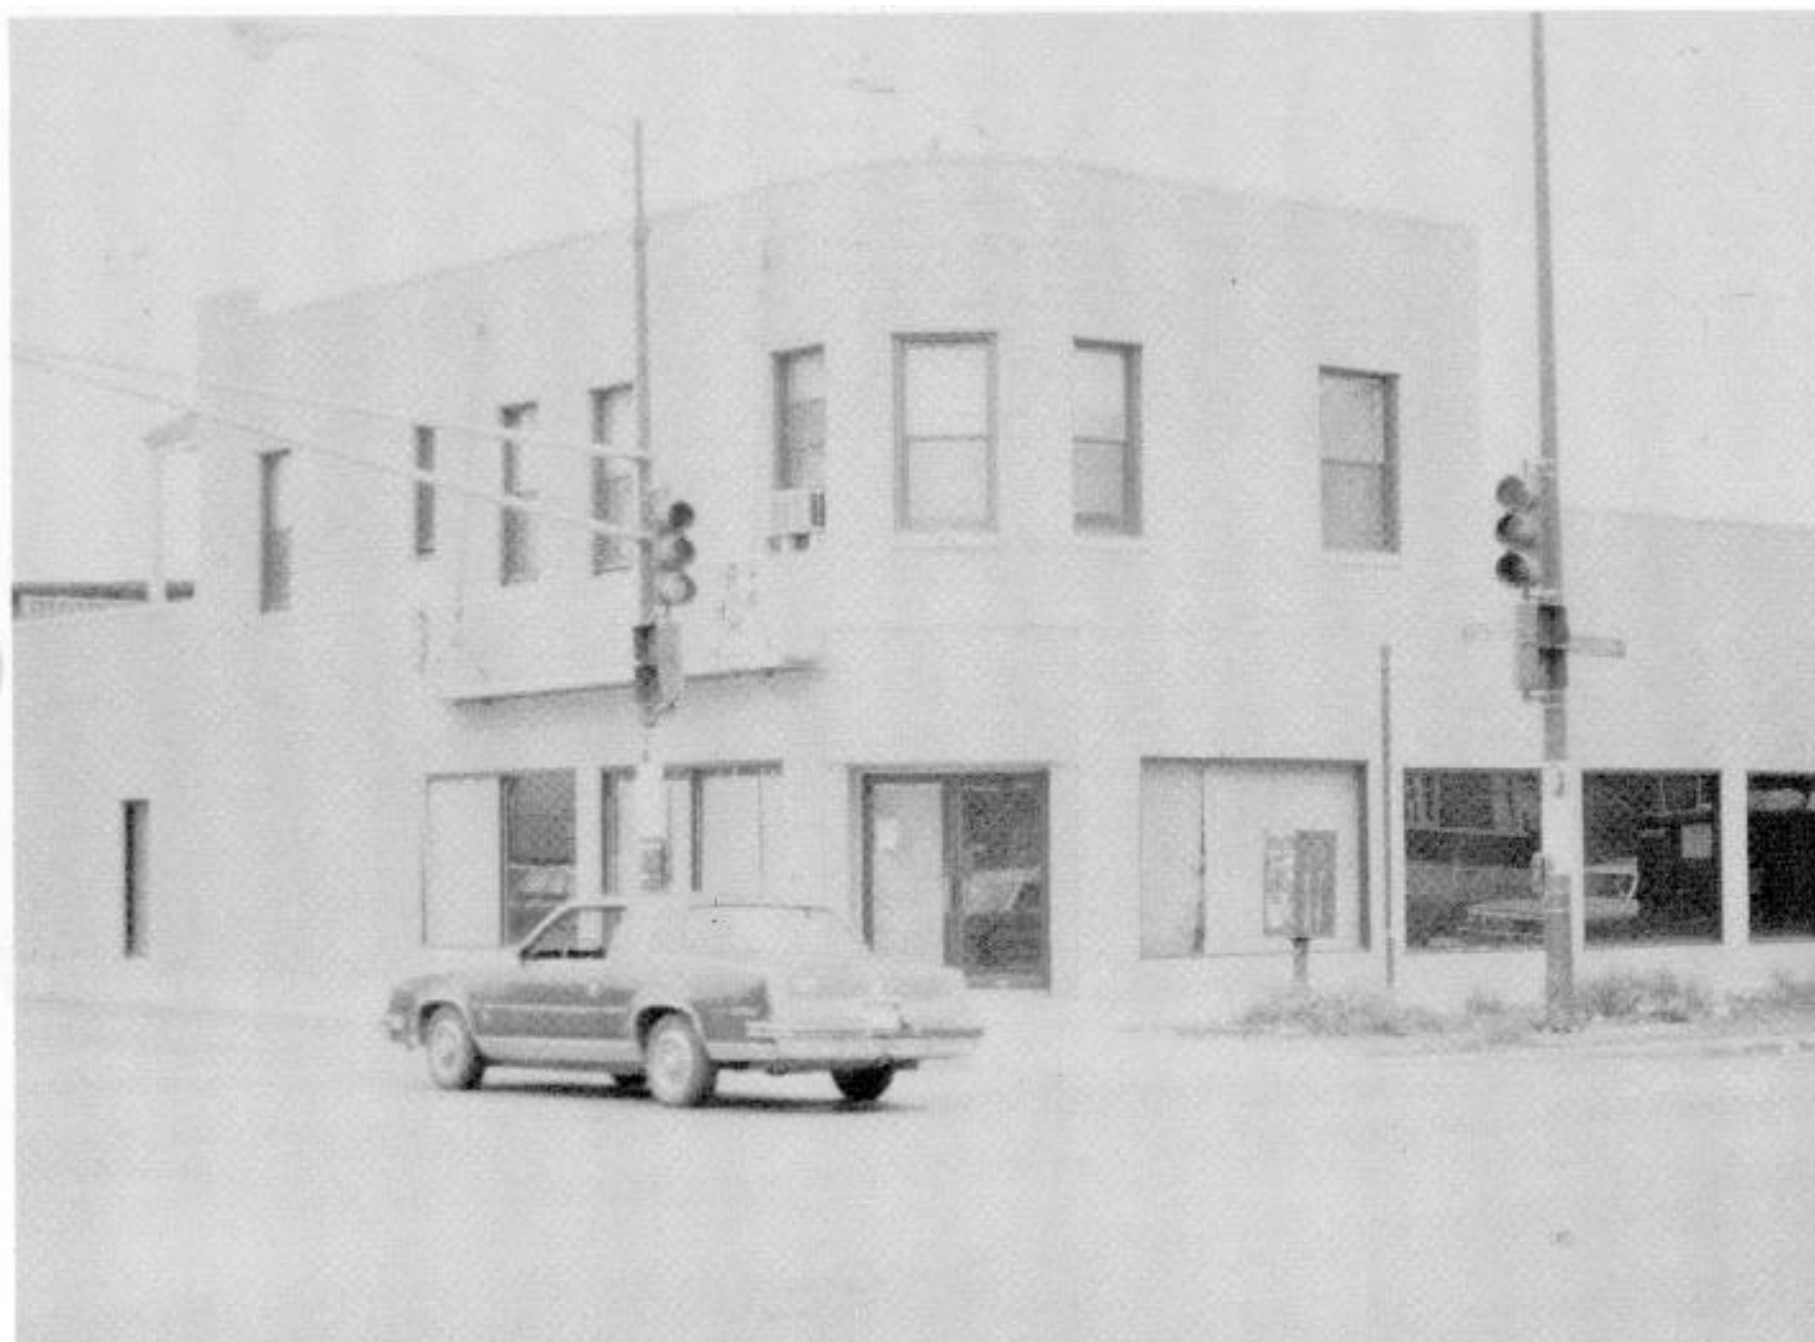
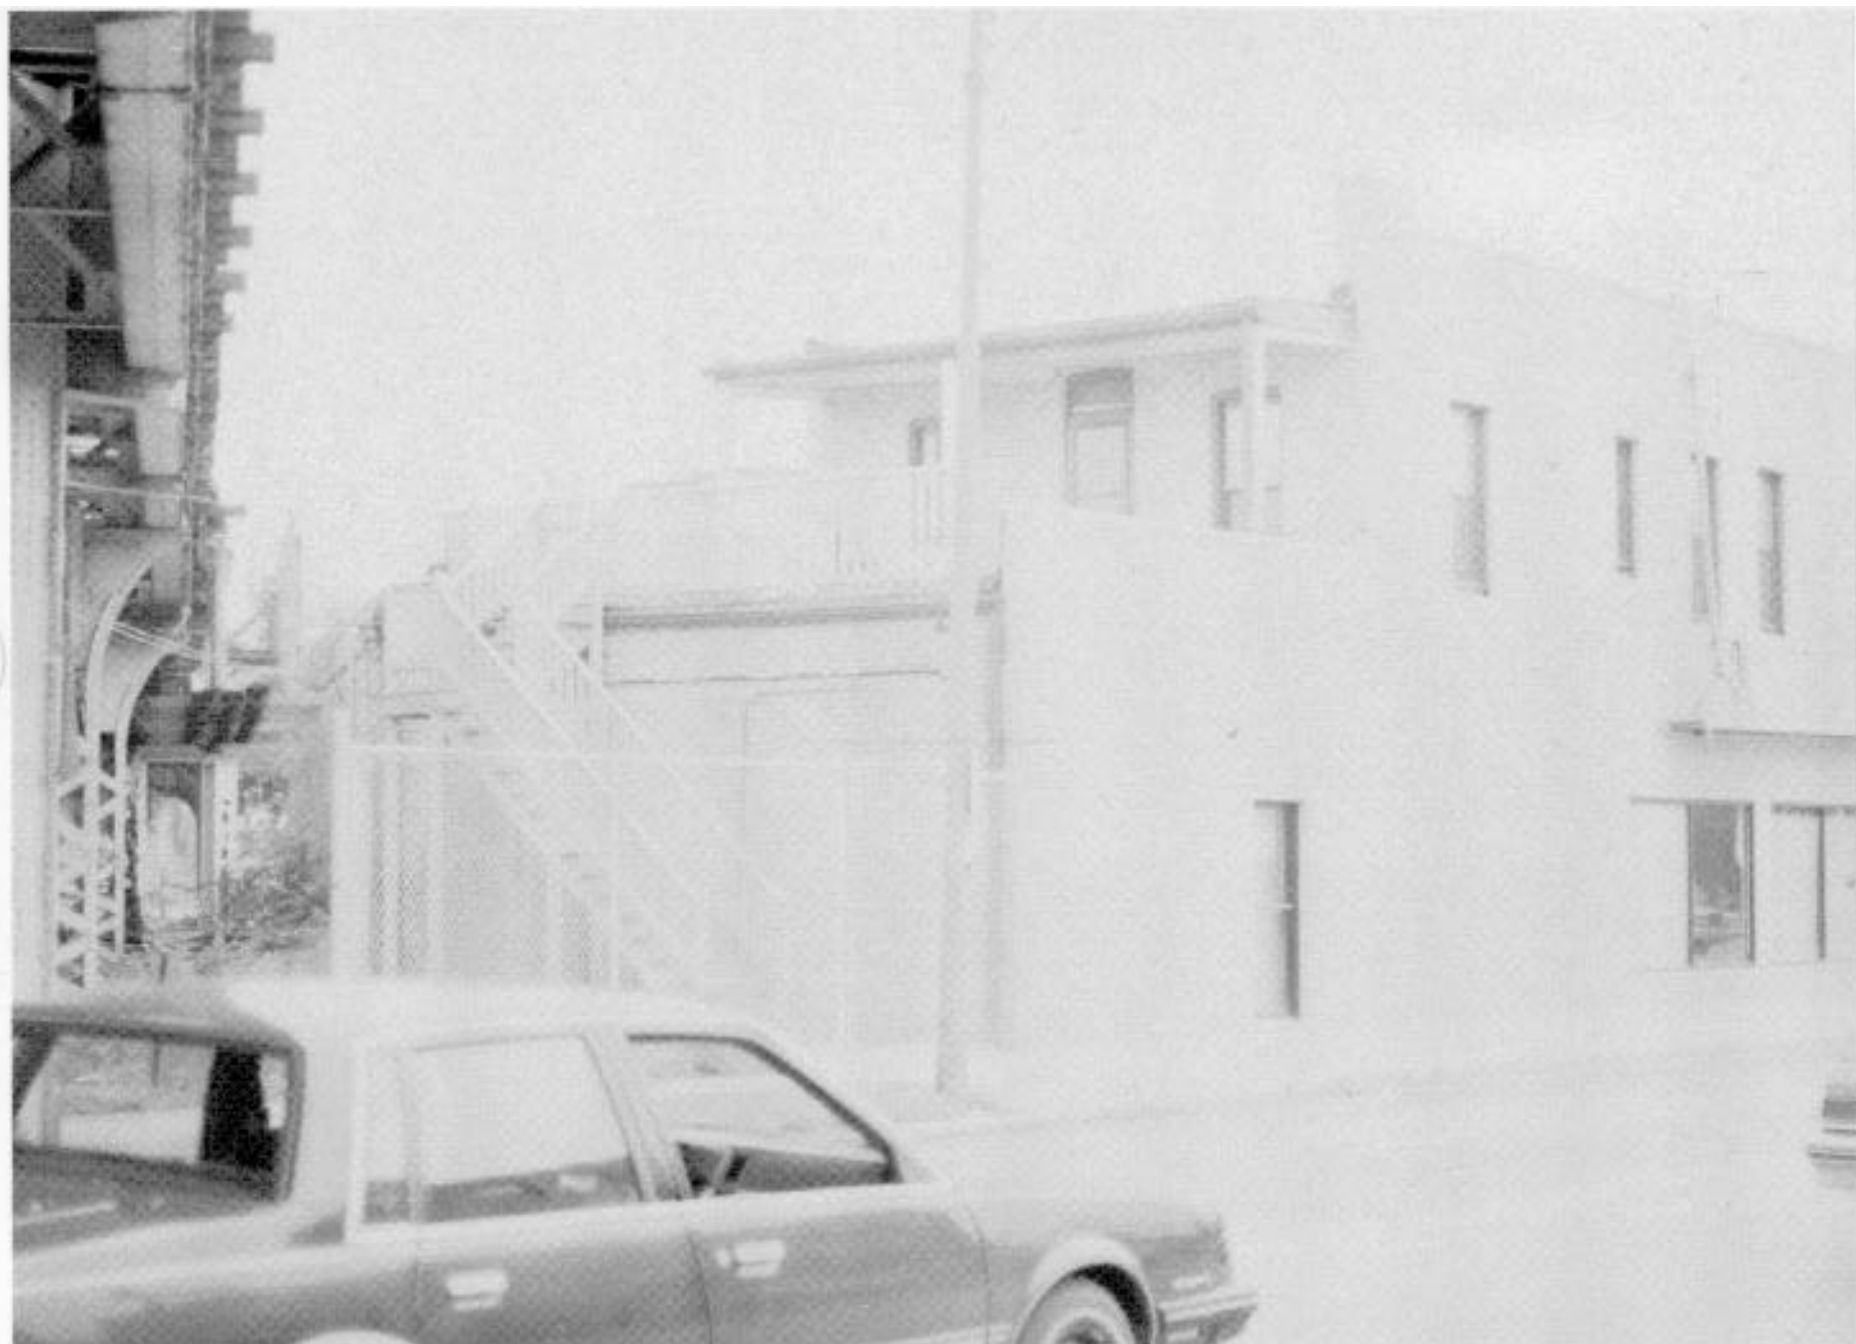
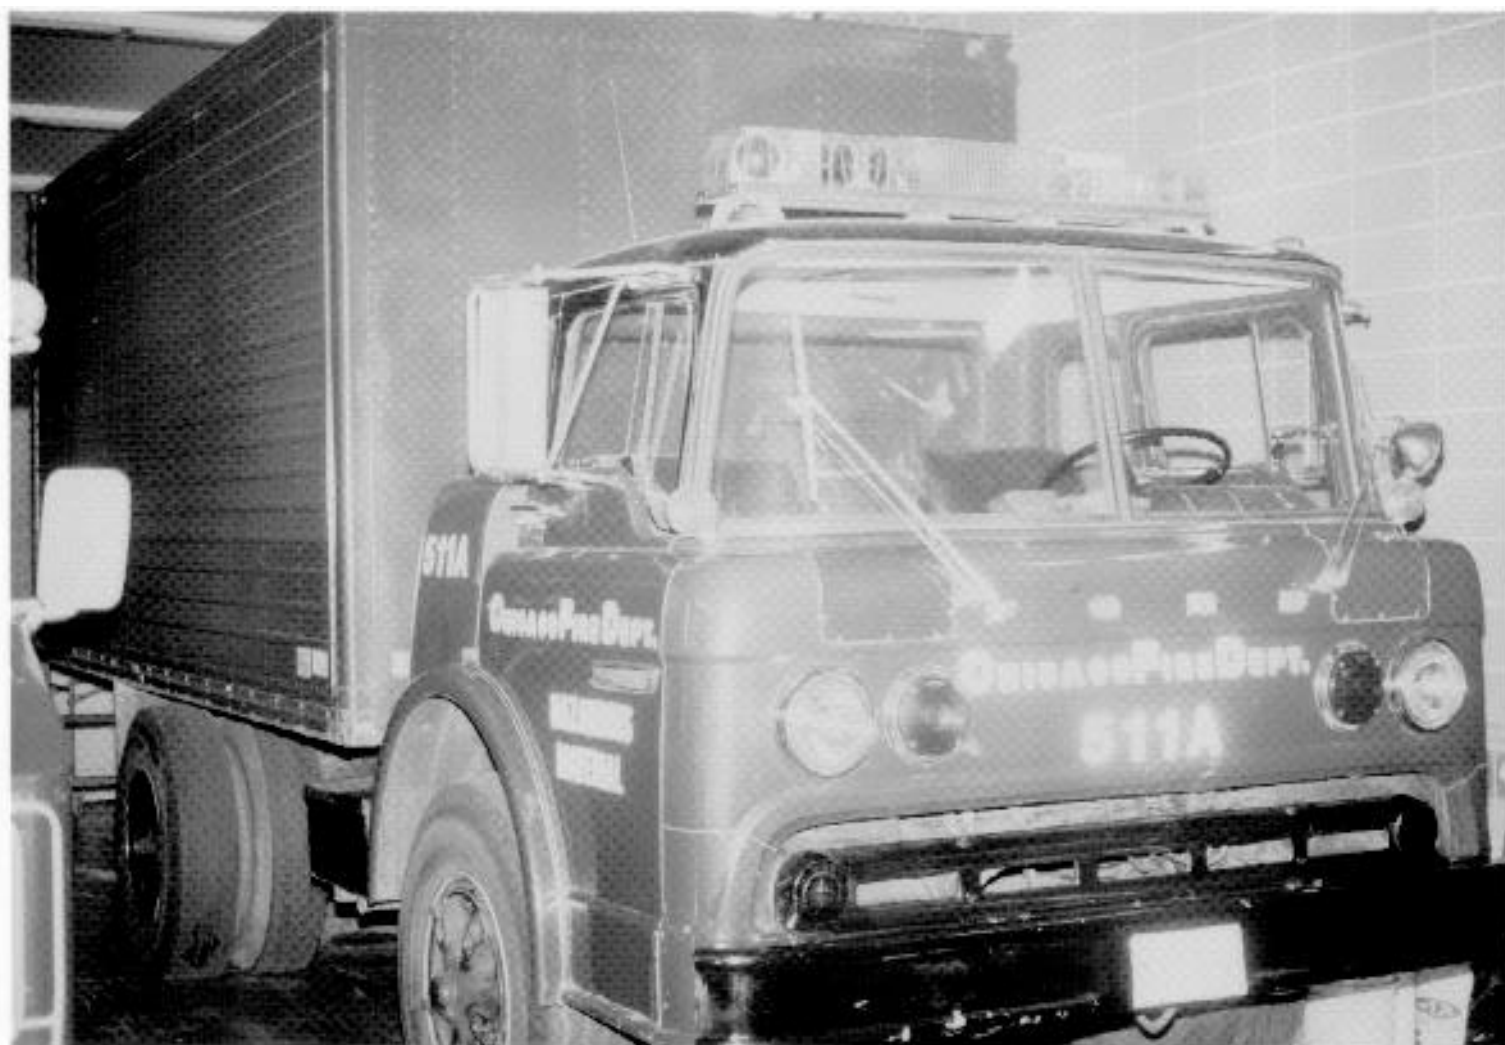
16. Primary exposure building weeks after the incident. Note reflection of dumpster in windows on right hand side.
17. Rear of primary exposure building showing proximity to "el" and access to second floor/roof.
18. 511A, Chicago's second piece of the Hazardous Incident Team. This unit carries absorbent, various supplies, and foam concentrate.
